# Management of extraction-related abscesses with collagen filler

### Clinical Case 1

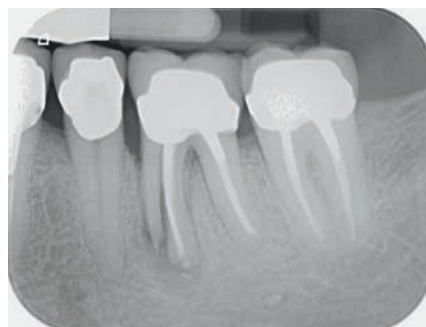
Fig. 01

A 65-year-old male patient presented for a check-up. Retroalveolar X-rays revealed a fracture in the mesial root of tooth 36 with no specific clinical signs (*Fig. 1*). The decision, taken together with the patient, was to perform the extraction as quickly as possible to avoid an abscess and preserve as much bone as possible, in order to be able to proceed with a future dental implant (*Fig. 2*).

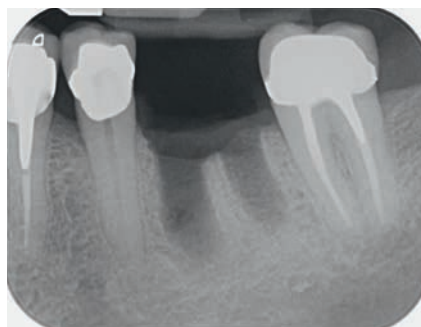
Fig. 02

At the time of the operation, residual loss of the vestibular bone wall was observed over three quarters of the mesial root of tooth 36. The

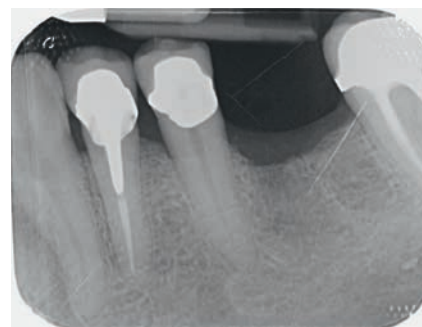
Fig. 03

A six-month follow-up X-ray suggested that the bone volume had been fully regenerated (*Fig. 3*), as confirmed by a cone-beam CT scan (CBCT). The Nobel Biocare Parallel CC implant was placed in a good-quality natural bone mass (*Fig. 4*) and a screw-retained FCZ crown was fitted (*Fig. 5,6*).

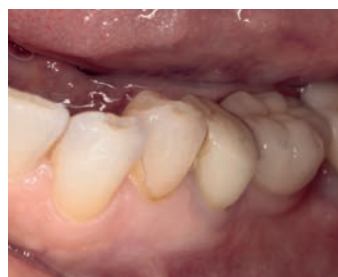
Fig. 11

A 60-year-old female patient presented with severe pain in quadrant 3 when chewing (*Fig. 11*) and a fracture of the root of tooth 35, which was confirmed by deep clinical vestibular probing and a retroalveolar X-ray (*Fig. 12*).
