Root canal re-treatment success with BioRoot™ Flow

Case Report

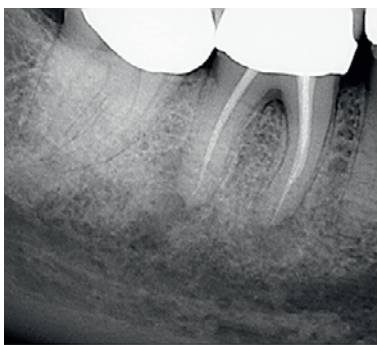
For radiographic diagnosis, a periapical (PA) radiograph (*Fig. 01*) and limited field of view CBCT were exposed (*Fig. 02a-d*). The previous endodontic treatment included obturation of three (3) canals, with inadequate density of obturation in the apical 1/3 of the M and D roots. Apical radiolucencies were present at the mesial (3x3 mm) and distal (3x5 mm) apices. The CBCT (*Fig. 02a-d*) confirmed an unobturated distolingual (DL) canal and possible middle mesial (MM) canal; the coronal CBCT slice

Fig. 01 - Pre-operative PA Radiograph of tooth #30.

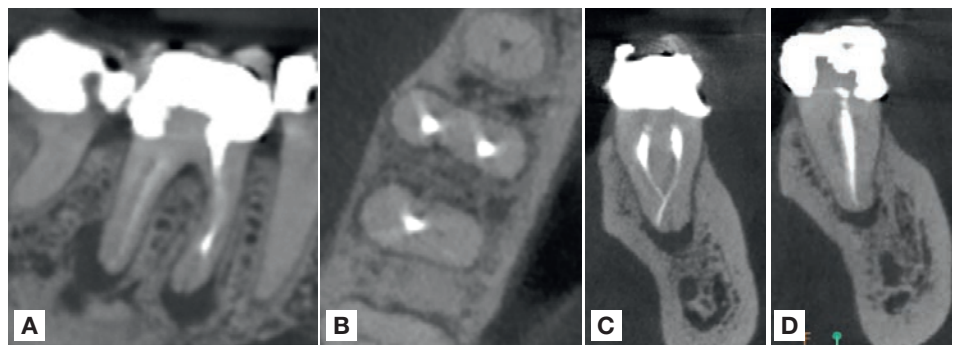
of the mesial root (*Fig. 02 c*) also suggests an apical delta, rather than a single apical foramen. No signs of cracks or fractures were visible.

Fig. 02 - Pre-operative CBCT Slices of Tooth #30. (a. Sagittal, b. Axial, c. Coronal view of Mesial Root, d. Coronal view of Distal Root).

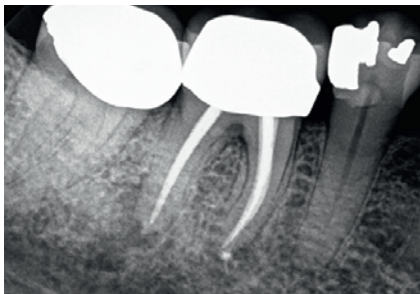
Fig. 03 - Immediate post-operative PA Radiograph of tooth #30 (same-day as root canal re-treatment) in June 2022.

A post-operative PA radiograph was exposed (Fig. 03) and home care instructions were reviewed.

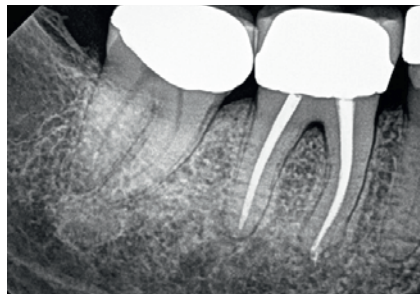
6-month Follow-up (January 2023): The patient returned for a routine follow-up appointment and stated, "I'm doing well!" A clinical exam was performed, and the mid-buccal probing had returned to a normal depth of <4 mm. All teeth in the quadrant were non-sensitive to percussion and palpation; there were no signs of erythema, swelling, or a sinus tract. The patient consented to a PA radiograph and limited field of view CBCT scan. The PA radiograph (Fig. 04) shows a small mesial sealer puff; the apical radiolucencies associated with the mesial and distal roots have decreased in size from June 2022 (comparison of Fig. 01 and Fig. 04).

Fig. 04 - 6-month Follow-up PA Radiograph of tooth #30 in January 2023 ; Significant apical healing has occurred and full apical healing is expected within the coming 3-6 months.

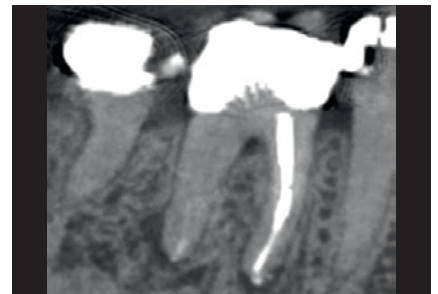
The CBCT (Fig. 05) shows a significant decrease in the size of the apical lesions, demonstrating excellent healing at the 6-month mark. Recommendation: Follow-up in 6 months, since healing is expected to be near completion at the 12-month mark.

Fig. 05 - 6-month Follow-up CBCT Sagittal View of tooth #30 in January 2023 ; Significant apical healing has occurred and full apical healing is expected within the coming 3-6 months.

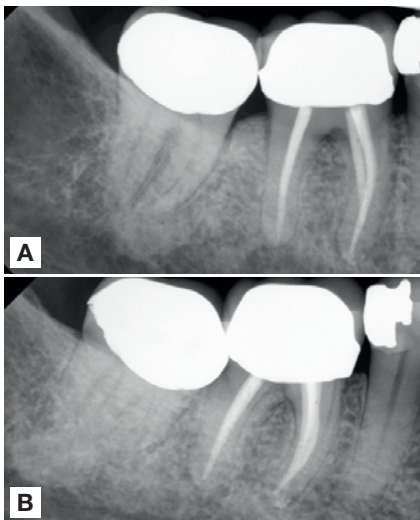
12-month Follow-up (June 2023): The patient states "I'm doing well. Just here for a routine check." The patient is asymptomatic and probing depths were all <4 mm around #30. Tooth #30 was non-sensitive to percussion and palpation, with physiologic mobility. The patient consented to PA radiographs (Fig. 06 a-b) and a limited field of view CBCT scan (Fig. 07 a-c). The PA radiographs (Fig. 06 a-b) show signs of healing at both the mesial and distal apices.

Fig. 06 - 12-month Follow-up PA Radiographs of tooth #30 in June 2023.

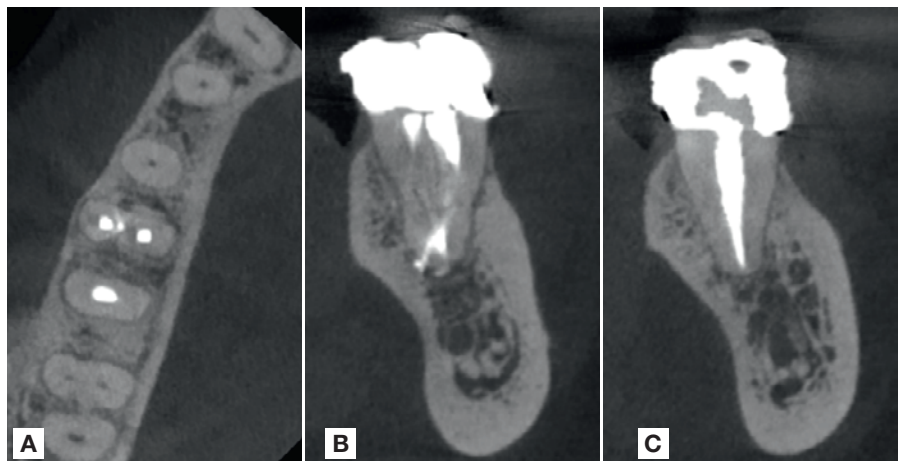
The CBCT (Fig. 07 a) highlights the obturation of the middle mesial canal, and the convergence/joining of the DB and DL canals. The M and D coronal views (Fig. 07 b-c) confirm apical healing of both roots. Clinical and radiographic findings indicate #30 as healed. No further follow-up is required unless the patient or her dentist notice changes in clinical or radiographic signs/symptoms.

Fig. 07 - 12-month CBCT Slices of Tooth #30. (a. Axial, b. Coronal view of Mesial Root, c. Coronal view of Distal Root).
